California Division of Mines and Geology
Fault Evaluation Report FER-172
Southern Newport-Inglewood Fault Zone,
Southern Los Angeles and Northern Orange Counties

William A. Bryant
Associate Geologist
October 30, 1985

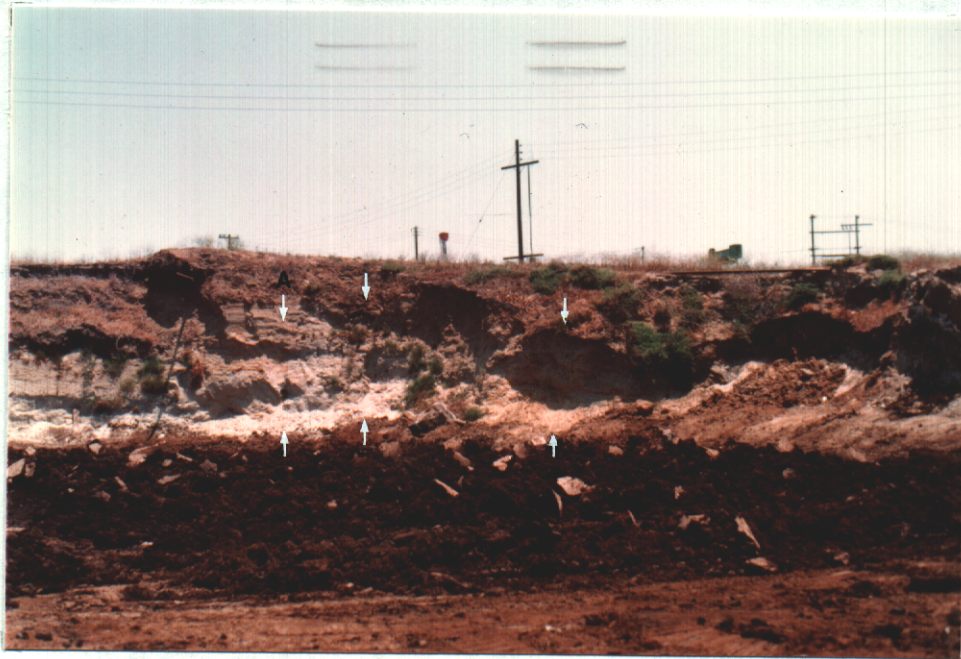
WCC (1984) logged several cut slopes and trenches along the North Branch fault along the west edge of Huntington Beach mesa (locality 7, figure 2a). A zone of faulting about 24 meters wide was observed in cut slope C-1 (figures 2a, 5). A marine sand unit contained fossils, which suggested an age of the sand of about 120 ka (WCC, 1984). This marine sand unit could not be correlated across the fault, indicating a significant, though indeterminant, amount of lateral or vertical offset. The principal fault zone, which consists of 3 near-vertical shears, apparently does not offset an overlying B soil horizon. However, WCC (1984, p. 24) stated that some traces of the major fault zone could be traced up into the base of the soil zone, but that the soil had been highly disturbed by animal burrowing. In addition, old oil field grading operations have disturbed surface and near-surface conditions.

Photo 1. View northeast of borrow pit on [#]northwest side of Huntington Beach mesa. Main trace of North Branch fault (arrows) was identified by WCC (1984) (see figure 5). The fault zone is about 25 meters wide at this location. Refer to photo 2 for detail of fault (A).

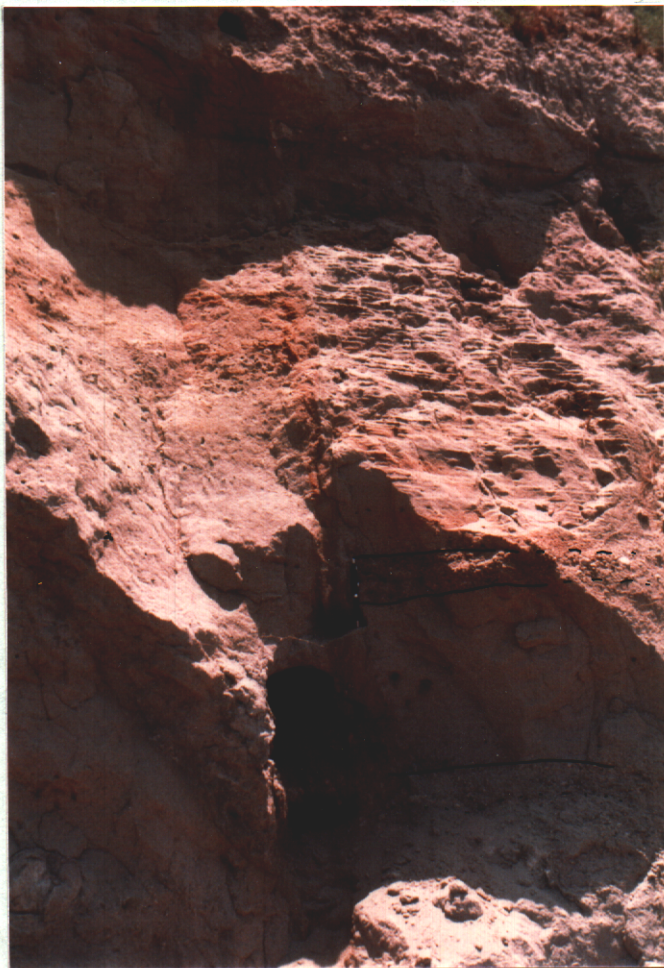
Photo 2. Close-up [#]of fault segment delineated by arrow A in photo 1. Gravelly sand beds on right side of fault were not observed on left side of fault, indicating a significant but indeterminant amount of lateral or vertical offset. The trend of the fault is $N60^{\circ}W\ 87^{\circ}SW$; additional fault segments trend $N40^{\circ}W$ and have a near-vertical dip.

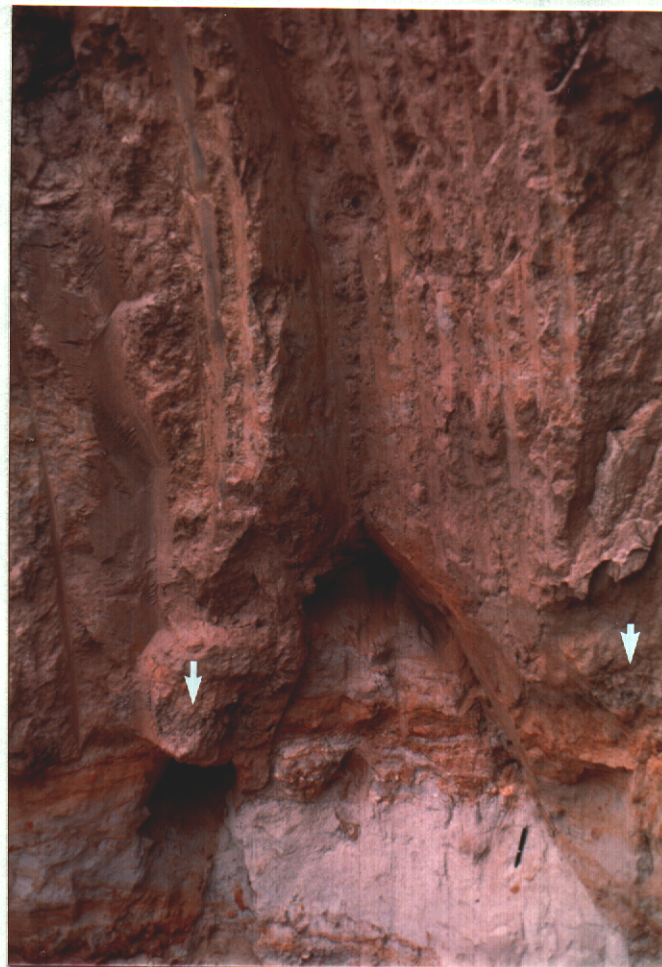
An approximately 90-meter-wide zone of faults was observed by this writer along the southwestern side of Newport mesa (locality 18, figure 3b). The faults had relatively minor apparent vertical displacements of up to 1 meter. A small branch fault on the southwestern side of the zone appears to offset a soil unit similar to the paleosol at the "horst block" site described by Guphill and Heath (figure 7).

Photo 3. View northwest of 'horst block' exposed on Newport mesa (locality 8, figure 2b); pencil for scale. Trend of shears bounding horst block varies from N22°W to N30°W. Paleosol (arrows) and B soil horizon are offset. Refer to figure 7 for log of this feature.

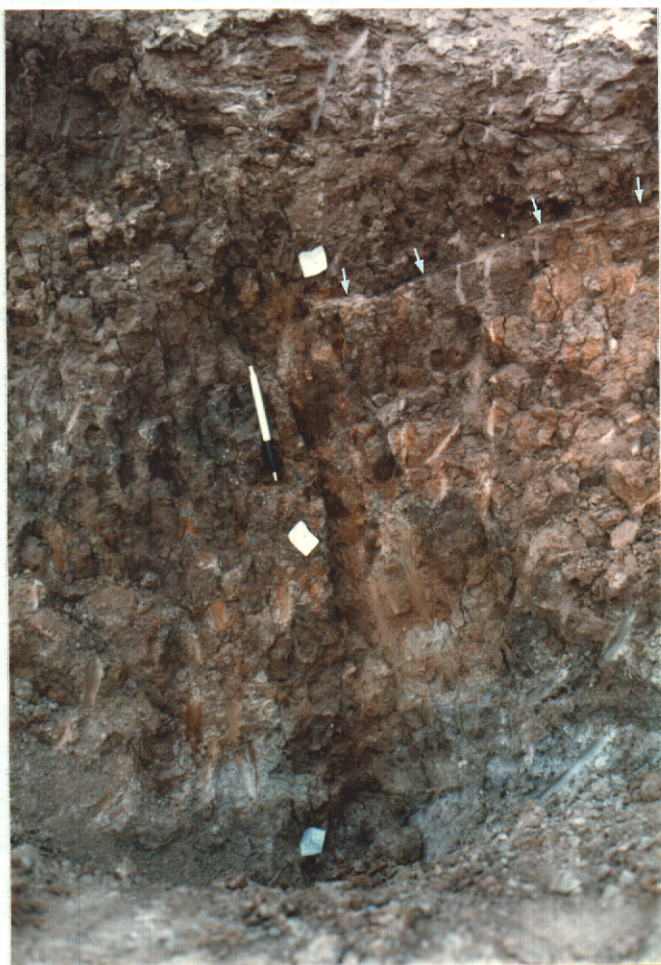
Evidence of possible historic surface faulting was observed about 120 meters to the southeast along an east-facing cut slope (Guptill and Heath 1981) (figure 2b). A fault was traced from the base of the slope upward through late Pleistocene deposits. The fault vertically offsets a B soil horizon and older fill (figure 8; photo 4). A distinctive laminated fine sand, called "puddle deposit" by Guptill and Heath (1981), is thought to represent a former ground surface. Old, pre-1933 fill was placed on top of the puddle deposit; both are offset, the sand about 30 cm, down-to-the-west (figure 8; photo 4). Guptill and Heath (1981) concluded that these data document historical surface faulting on Newport mesa, probably associated with the 1933 Long Beach earthquake.

← Photo 4. View north of offset pre-1933 fill on Newport mesa that was first described by Guphill and Heath (1981). The fault plane, delineated by white squares, trends N32°W 85°NE. Pre-1933 fill overlies 'puddle deposit' (arrows), a thin, laminated fine sand. This deposit, which overlies a B_{2t} soil horizon on the right side of the fault, was not observed across the fault. Light grey material at base of the exposure is late Pleistocene terrace deposits. Refer to figure 8 for log of this exposure. (Note: exposure had been cut back about 1 meter since the time of the Guphill and Heath log)

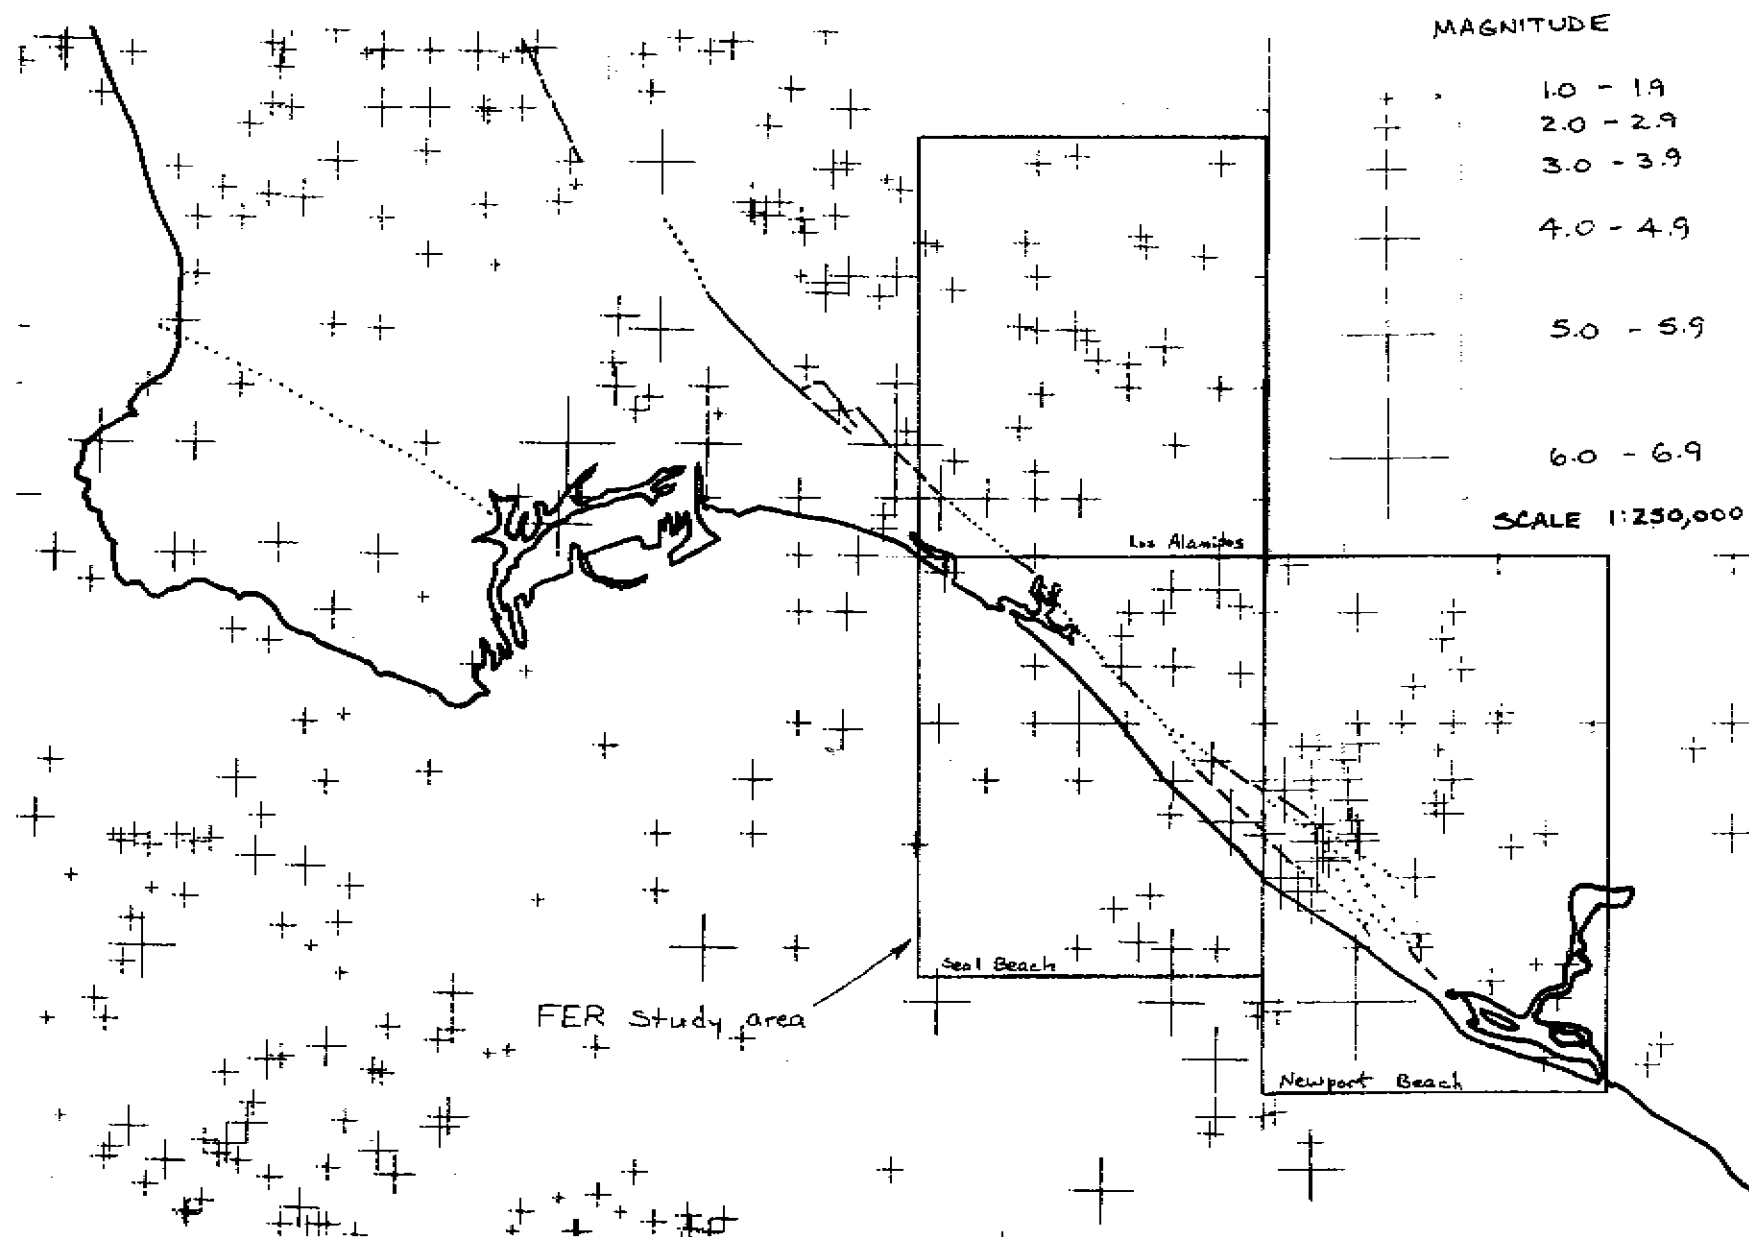
The Newport-Inglewood fault zone is seismically active (figure 9). The 1933 M6.3 Long Beach earthquake occurred along the Newport-Inglewood fault zone approximately 5.6 km offshore from Newport Beach. No surface rupture was reported to have occurred during this earthquake, although considerable ground failure due to shaking (liquefaction, seismic settlement, lateral spreading) was reported (Barrows, 1974). WCC (1979) concluded that the best-fit focal mechanism for the 1933 Long Beach earthquake is right-lateral strike-slip along a N40°W-trending, near-vertical fault with a focal depth of about 10 km. The average displacement at depth along the fault during this event (from seismic moment calculations) is 31 to 46 cm.

Figure 9 (to FER-172). Seismicity (A and B quality) in the study area for the period 1932 to 1984, based on locations from California Institute of Technology. Faults are from Jennings (1962) and Rogers (1965).
